# CHURCH OF THE HOLY SEPULCHRE JERUSALEM

STRUCTURAL SURVEY  
FINAL REPORT

WILLIAM HARVEY

1935

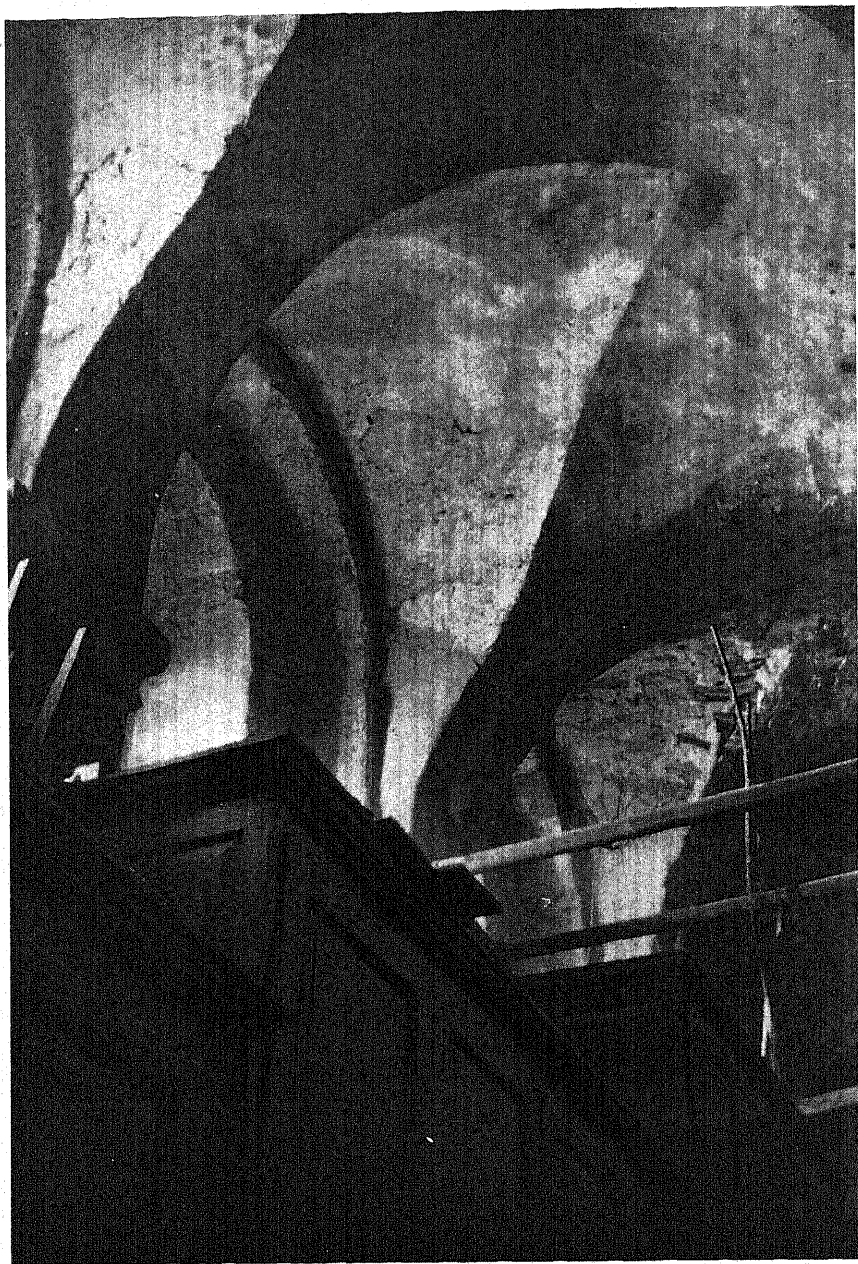
During plastering which took place eighteen months ago, it was found that the vault of the upper gallery was not in contact with the outer wall in many places (see Fig. 10); the very large cracks then visible are now hidden by the new plaster, but within the last few months the plasterwork has again shown cracks in the same positions as the hidden defects, thus indicating that movement is now continuing. The carved stone capitals of the attached half-columns supporting this vault are badly cracked owing to the pressure and torsion to which they are subjected.

FIG. 10. VAULT OF NORTH TRANSEPT UPPER GALLERY—  
BEFORE RE-PLASTERING

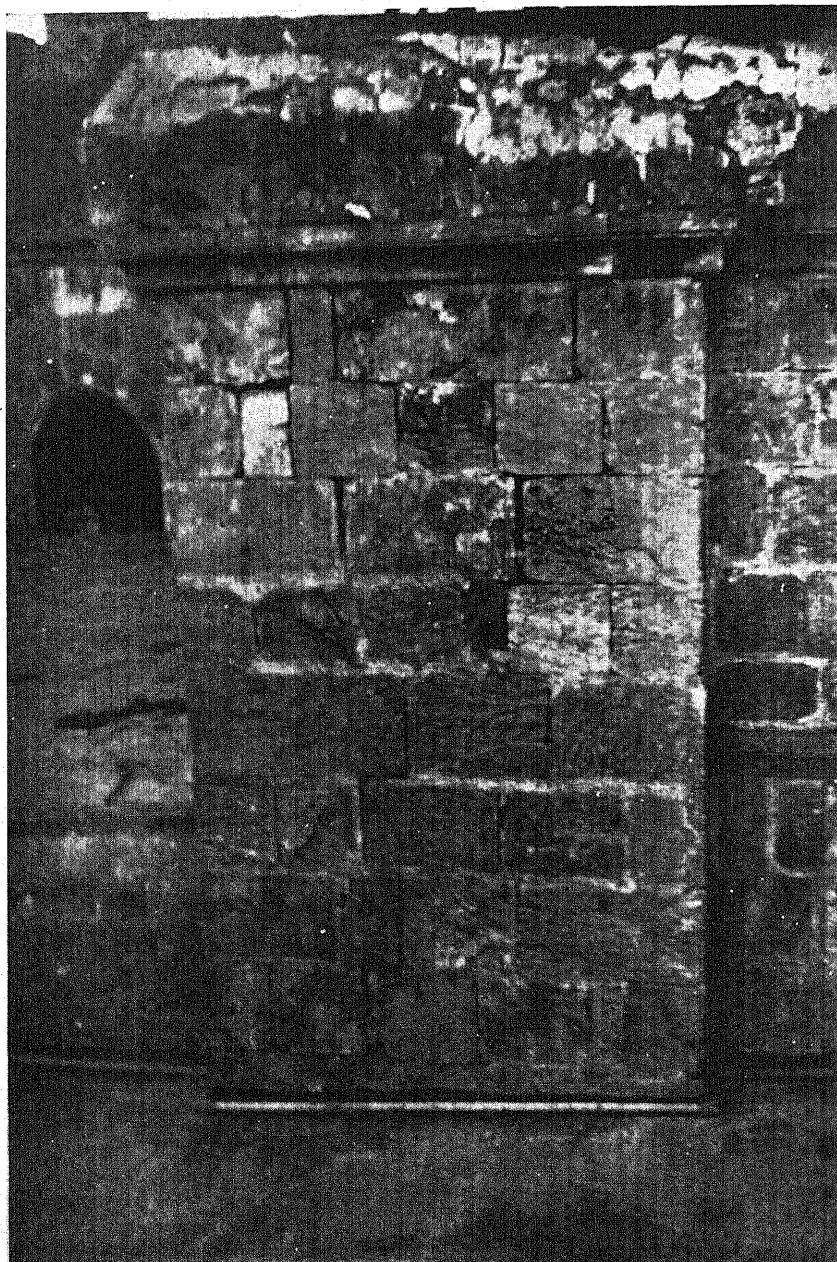
The high vault itself (see Fig. 11) has also been plastered, but some two years ago a large stone fell from one of the main ribs, and the upper walls, where accessible from outside, are in an extremely poor condition (see Figs 12, 13, 14), many joints being completely denuded of mortar, and much of the masonry cracked and suffering from erosion, and to some extent from the effects of the fire of 1808.

FIG. 12. N.E. CORNER OF NORTH TRANSEPT

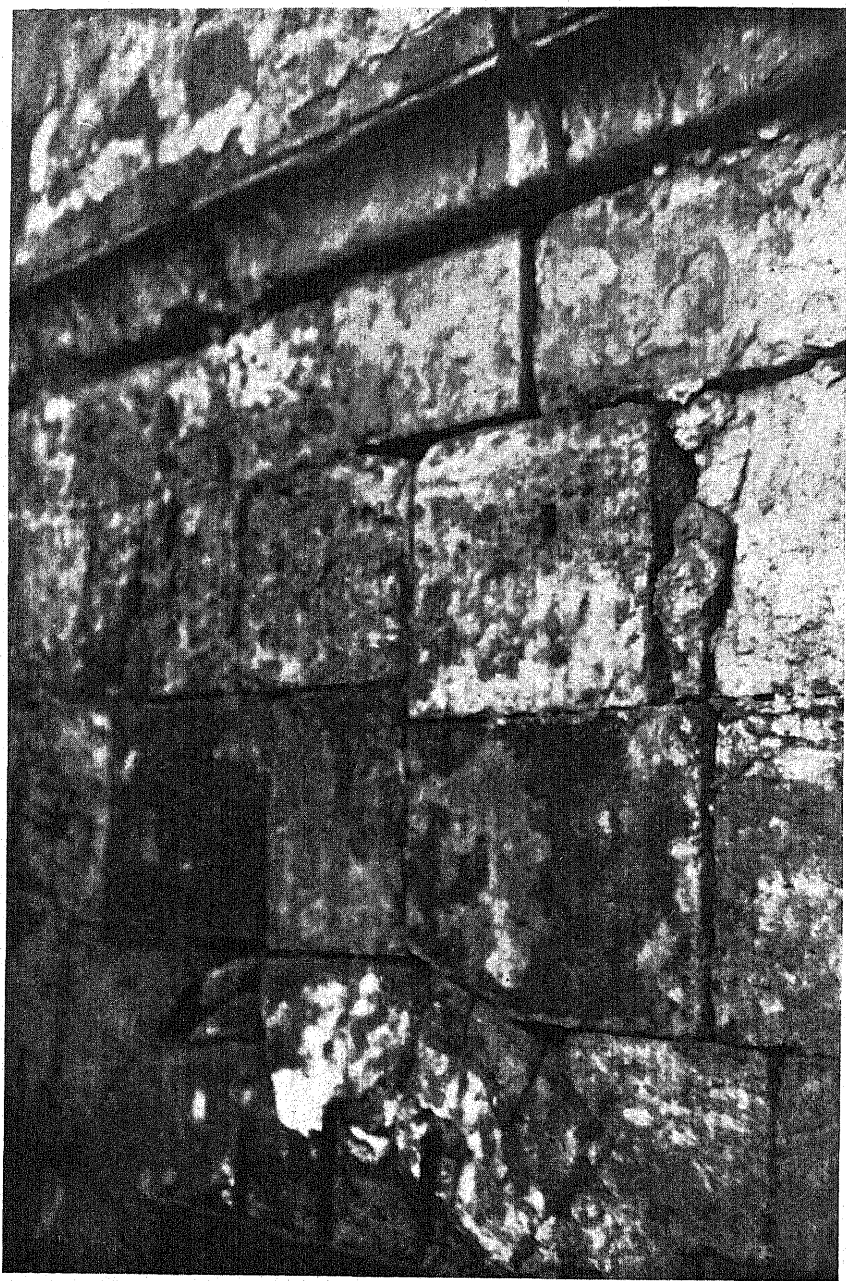
FIG. 14. NORTH TRANSEPT HIGH VAULT. E. WALL

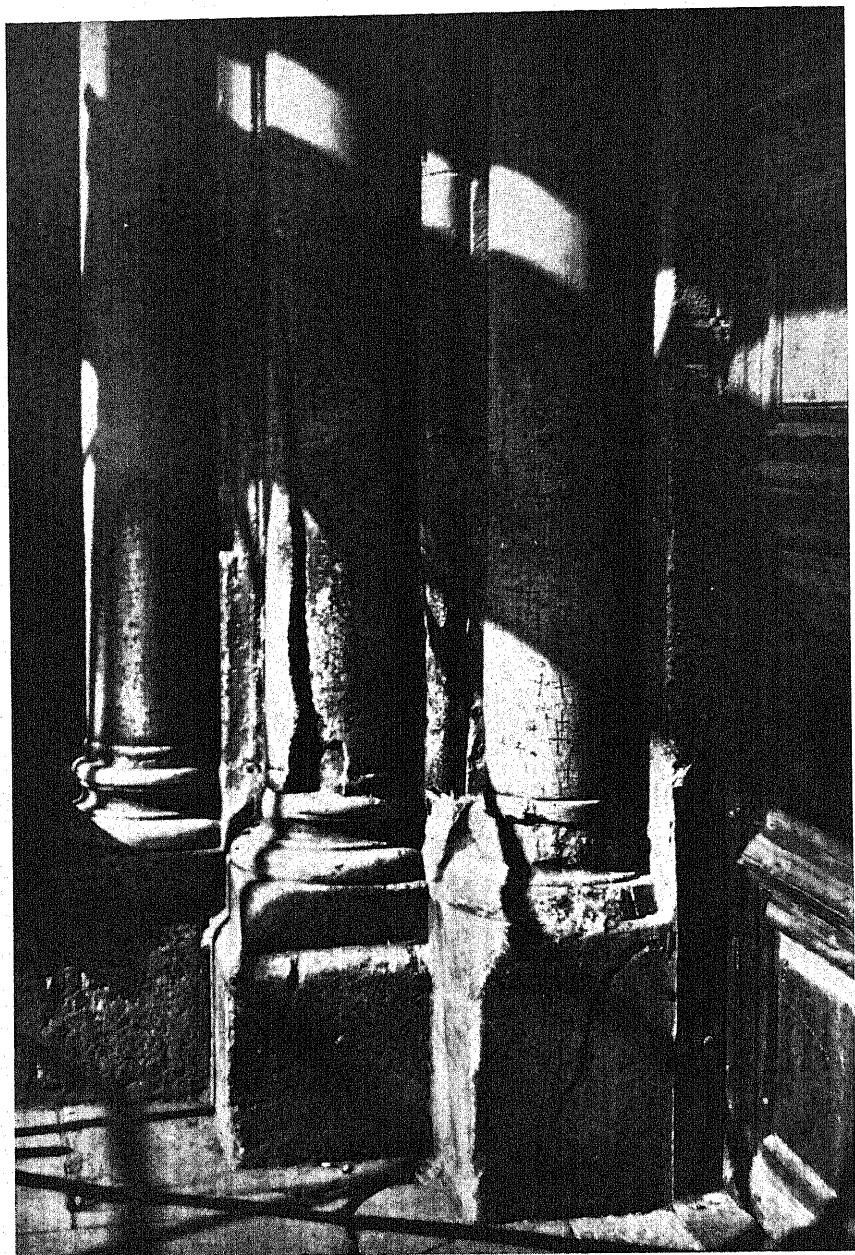
The lower colonnettes and their bases are almost all cracked, the oblique direction of the cracks showing the asymmetrical loading of the arches above (see Fig. 24). The condition of most of the carved work is extremely good (see Figs. 25, 26, 27, 28, 29) with the exception of the inner orders of the upper arches, which suffered most from the fire (see Figs. 30, 31, 32).

FIG. 24. BASES TO W. OF MAIN DOOR

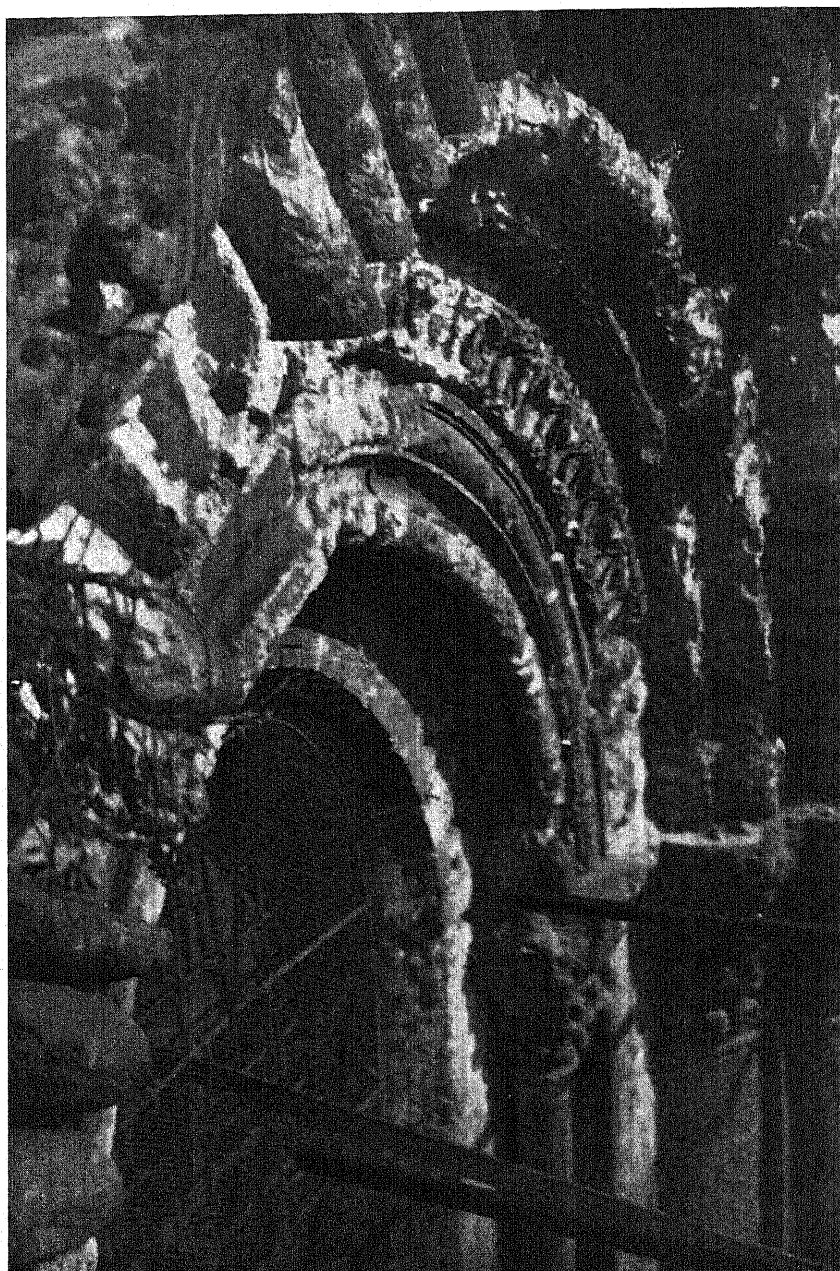
FIG. 30. UPPER ARCHES OF FRONT

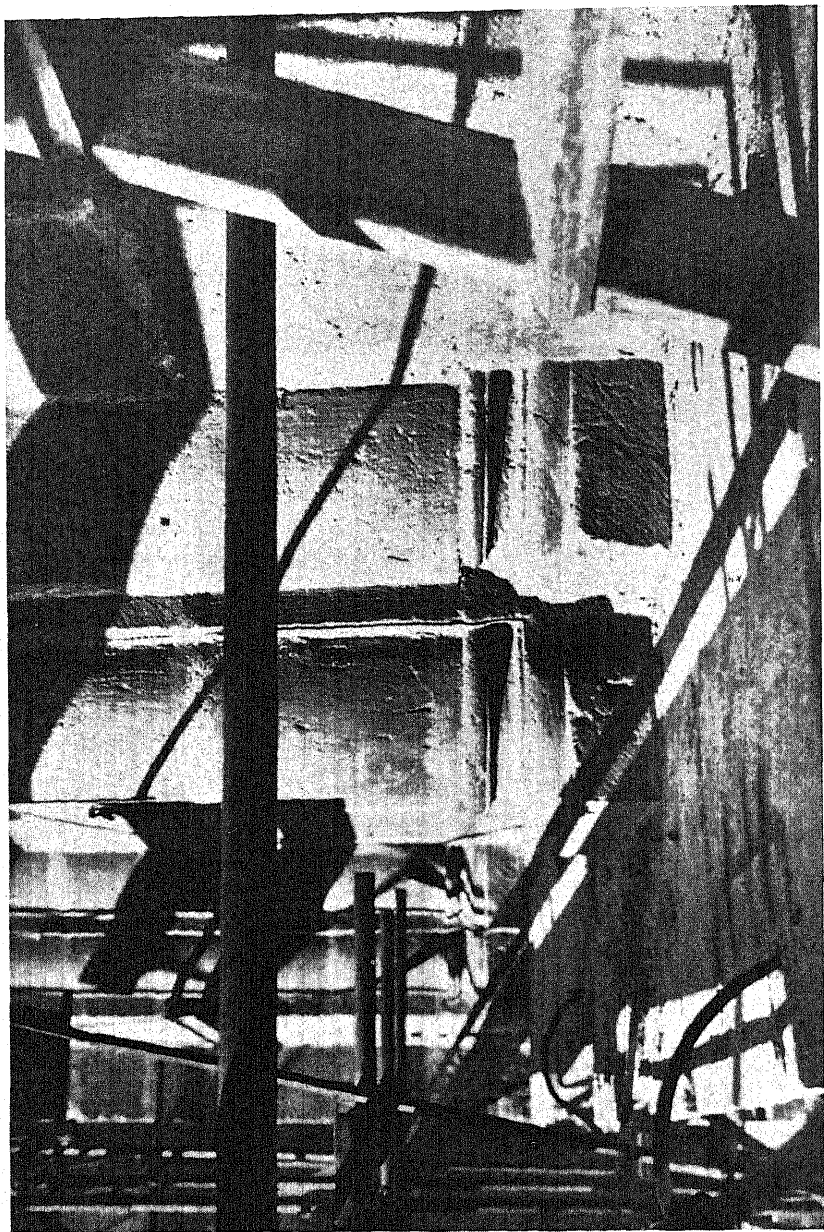
Serious cracks occur both from the outside of the wall (see Fig. 36) and in the attached pier within (see Fig. 37); while others between the vault and the wall have been covered by plaster (see Fig. 38) (see also Additional Notes, pp. 13 and 15).

FIG. 36. CRACKED BASES OF PIERS OF UPPER ARCADE

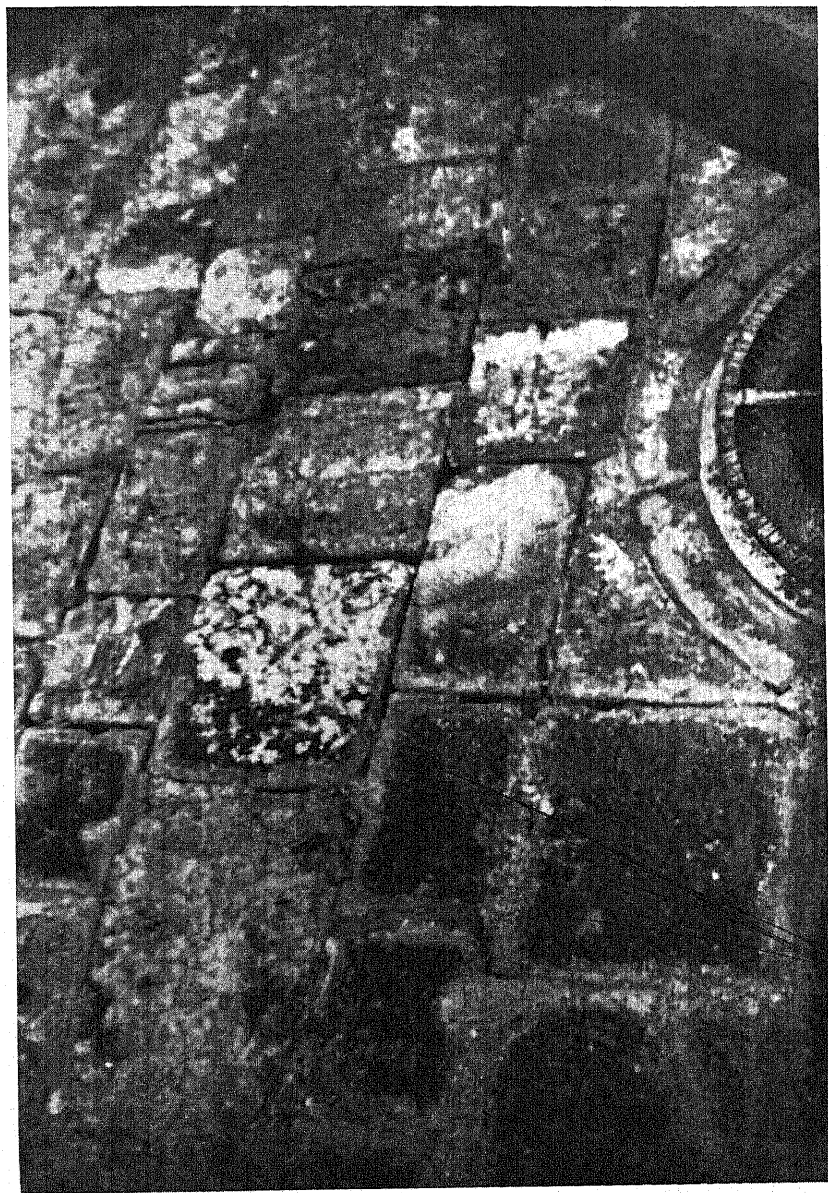
FIG. 36a. SOUTH TRANSEPT HIGH VAULT E. WALL TO SHOW FRACTURES  
IN MASONRY AND JOINTS

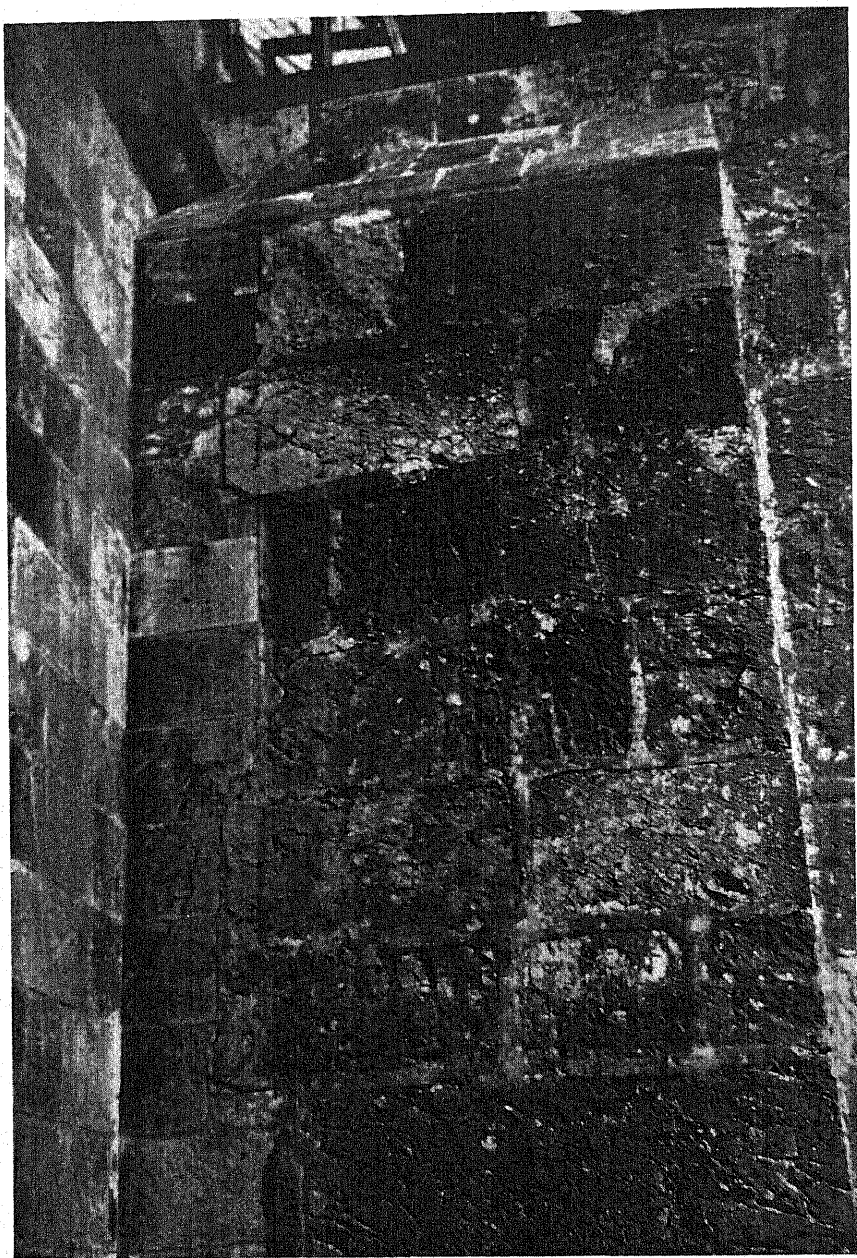
FIG. 36b. SOUTH TRANSEPT HIGH VAULT W. WALL  
TO SHOW CRACK

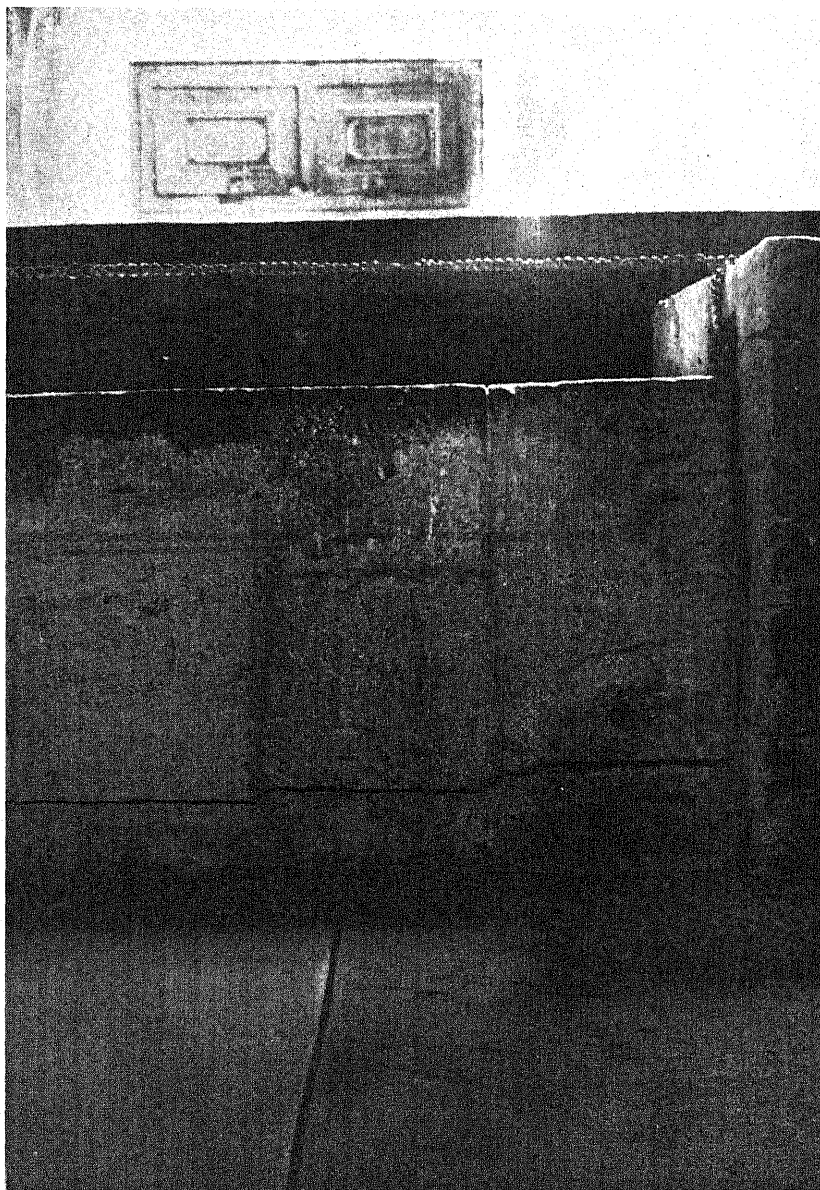
FIG. 37. FRACTURE IN ATTACHED PIER BETWEEN MAIN DOORS

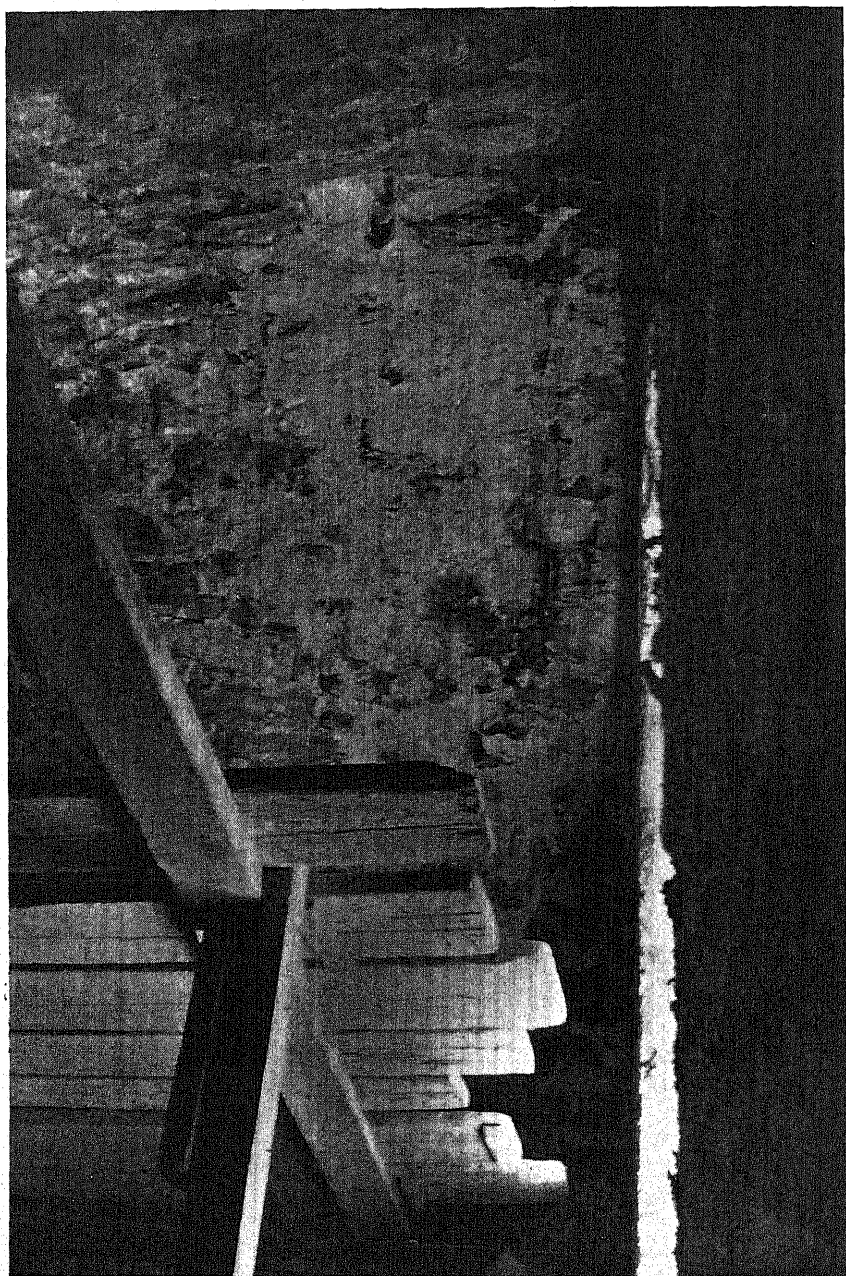
FIG. 38. CRACKED VAULT OF ARMENIAN GALLERY  
BEFORE RE-PLASTERING

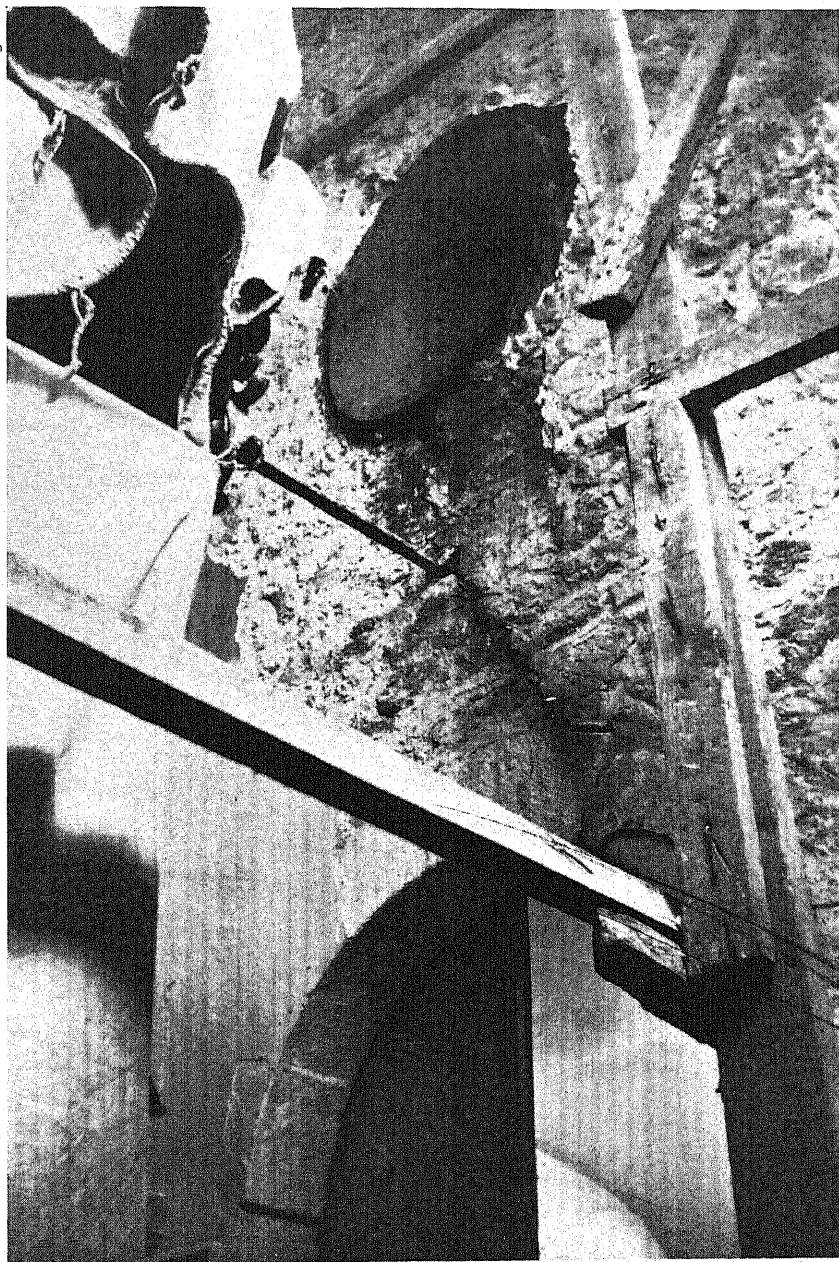
FIG. 38a. CRACK IN TRANSVERSE WALL OF ARMENIAN GALLERY  
BEFORE RE-PLASTERING

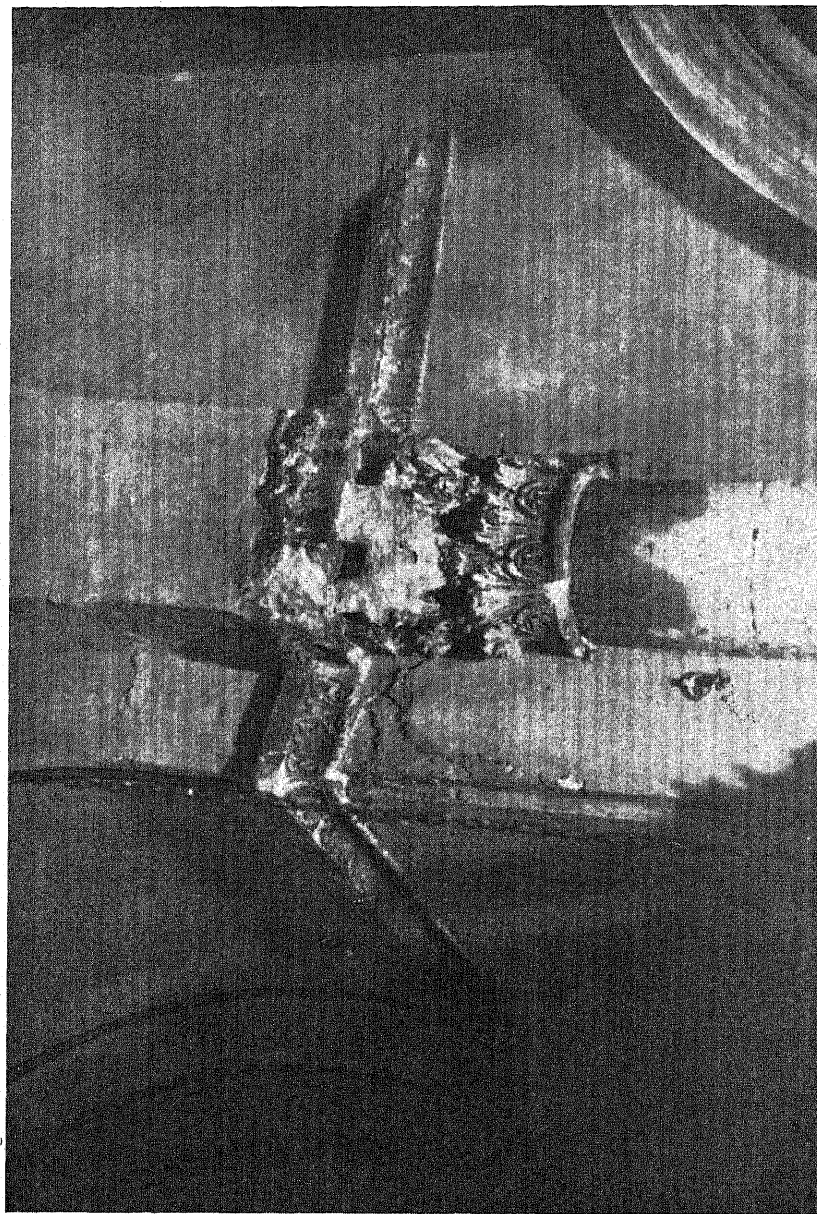
FIG. 43. CAPITAL DAMAGED RECENTLY. AMBULATORY

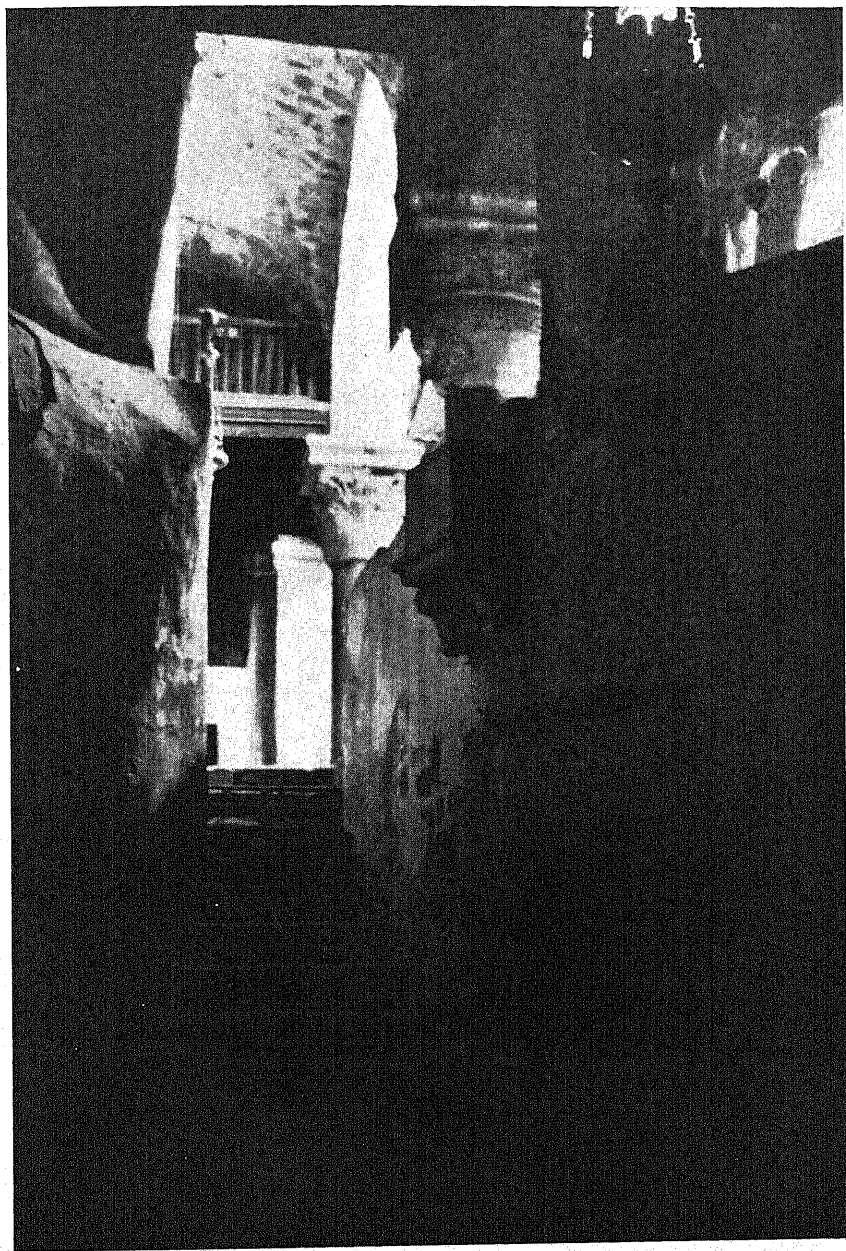
decay of structural consequence. The dome (see Fig. 46) leaks and requires water-proofing outside, as the rough-cast stucco has become badly cracked (see Fig. 47). The floor is in a bad state, also the flight of steps leading to the Grotto of the Invention (see Fig. 48); these are at present covered with iron gratings.

FIG. 48. STAIR TO GROTTA OF THE INVENTION

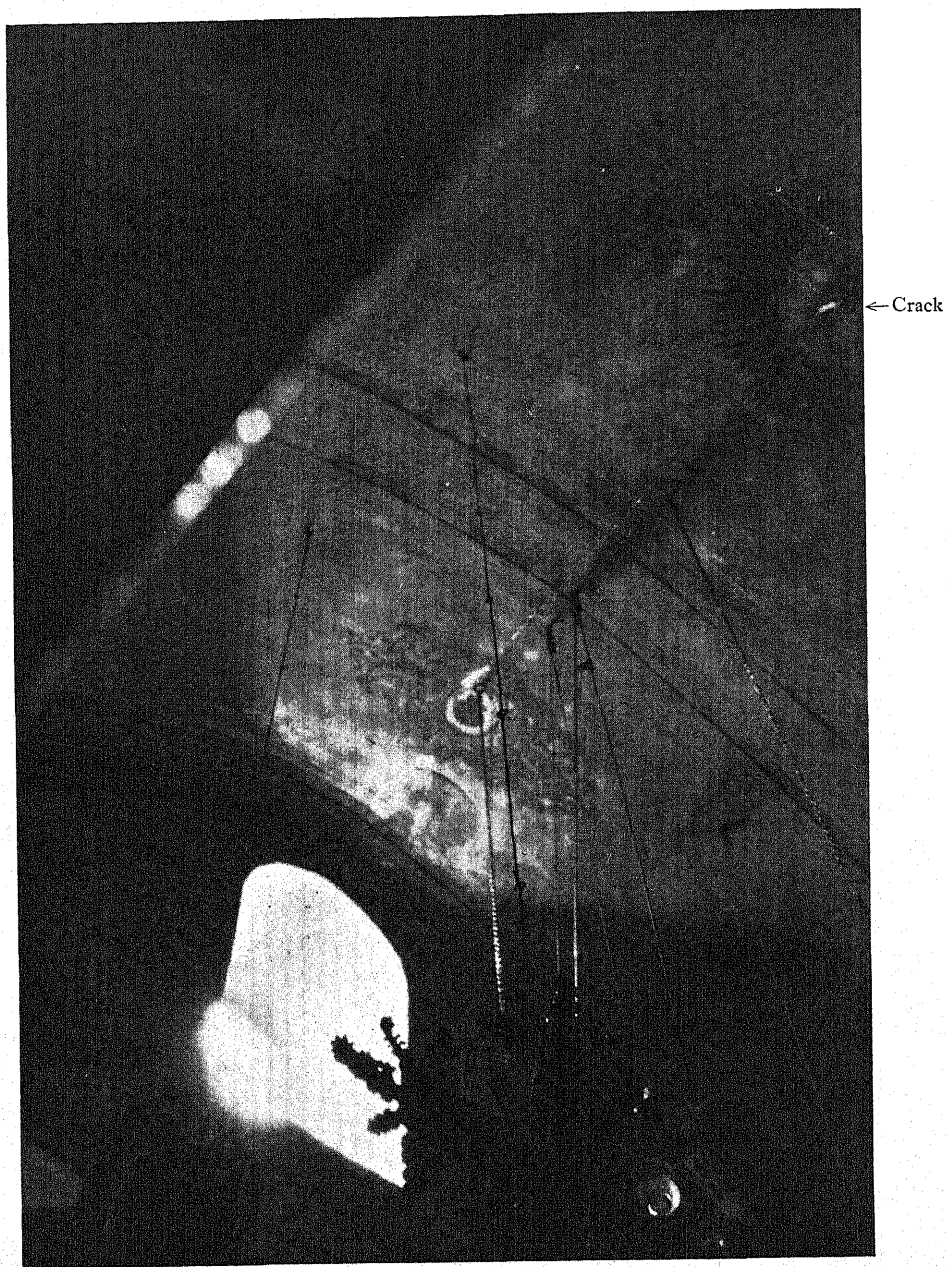
by  $22\frac{1}{2}$  centimetres, and the crown of the vault is cracked throughout its length (see Figs. 63, V).

FIG. 63. VAULT OF CHAPEL OF ST. JAMES

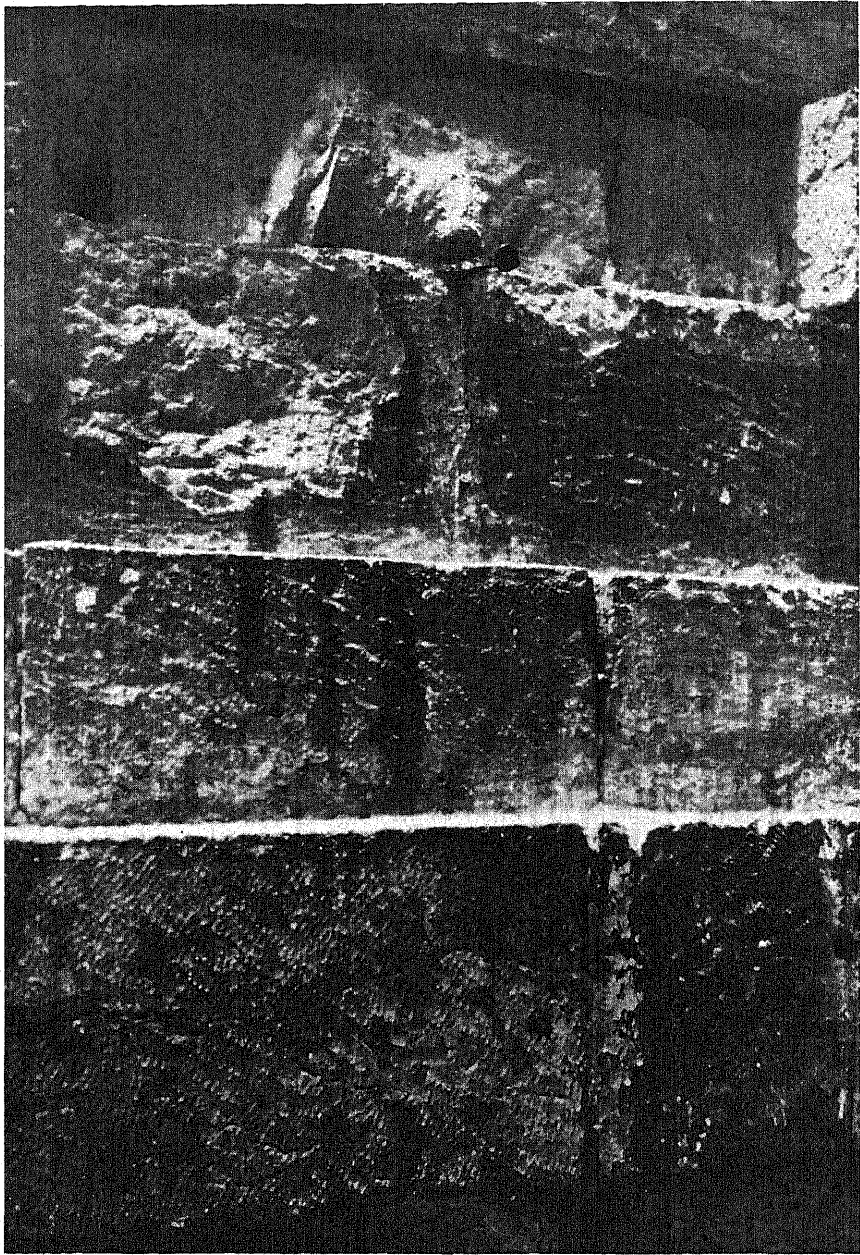
The piers of the main Rotunda (see Fig. I, 13) are now square (see Fig. 64), though they probably enclose as a core the earlier round columns of the building of Constantine Monomach (c. A.D. 1048). The present piers are clamped together with rusting iron (see Fig. 65), are very irregular in shape and size, and are not placed symmetrically beneath the circular drum built in 1867. They are therefore subject to eccentric loading, and all of them show cracks to a greater or less extent; some of these cracks are serious, though certainly due to earthquake shock as well as to thrusts (see Fig. 66).

FIG. 65. FRACTURES DUE TO RUSTING IRON CRAMPS.  
ROTUNDA PIERS

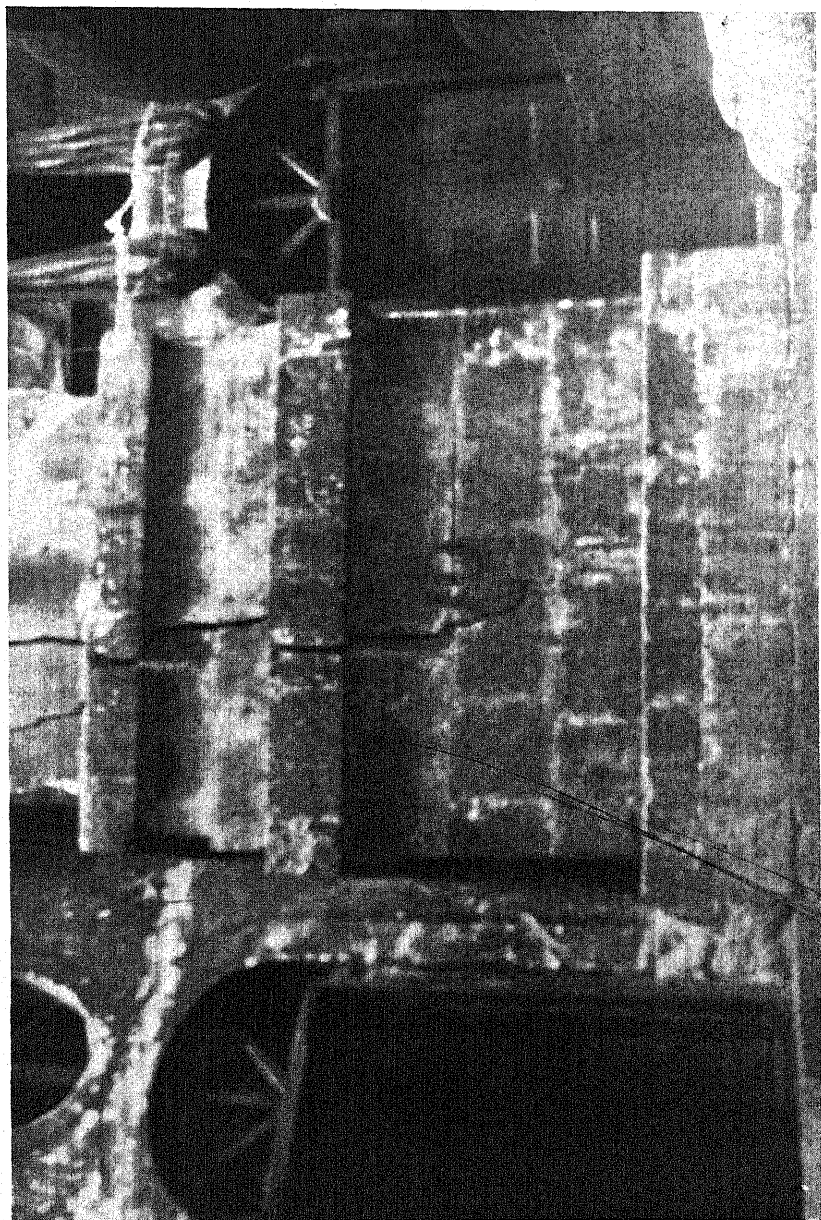
FIG. 66. FRACTURED PIER AT W. OF ROTUNDA
